# DECISION DOCUMENT Landfill Turn Table Area, SWMU J-26 Hawthorne Army Depot Hawthorne, Nevada April 2000

This decision document describes the rationale for the remedial action at, and closure of, Solid Waste Management Unit (SWMU) J-26, Landfill Turn Table Area, at the Hawthorne Army Depot (HWAD), Hawthorne, Nevada. This decision document was developed by the U.S. Army Corps of Engineers, Sacramento District (USACE), HWAD, and Day & Zimmermann Hawthorne Corporation, with support from the Nevada Department of Conservation and Natural Resources, Division of Environmental Protection (NDEP).

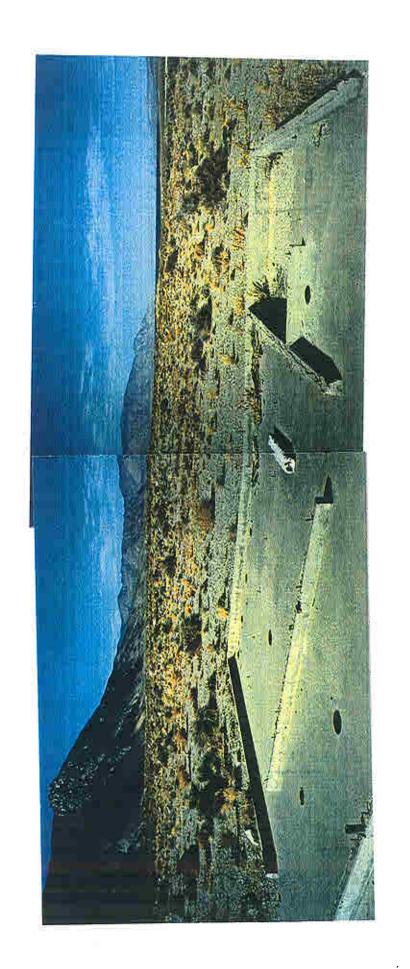
J-26, View to north (continuation of pan to west of #R8-P2) across former CCC camp building slab, with piece of asbestos pipe insulation. #R8-P3/4,

The suspected asbestos-containing material, including all pipe insulation, was removed from this SWMU and disposed of properly.

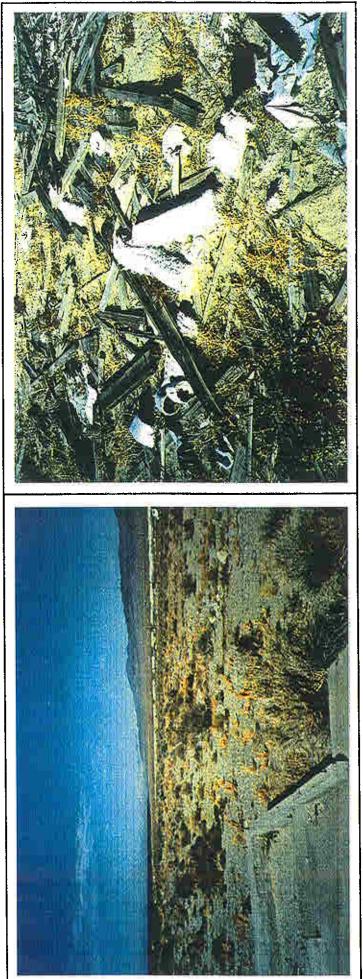
J-26, View to north (continuation of counterclockwise pan from #R8-P13, 11/5/93

J-26, Detail of asbestos pipe insulation among wood and debris. #R8-P14, 11/5/93

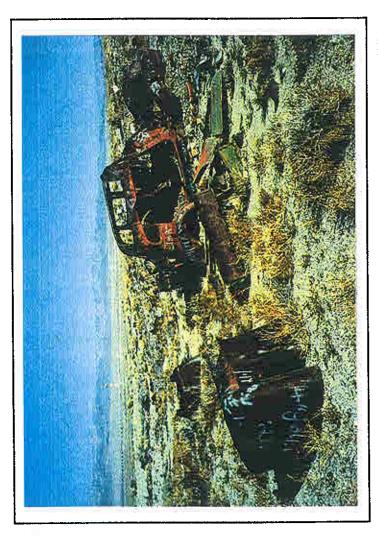
J-26, Close up of old car body and metal debris in old solid waste landfill. #R8-P19, 11/5/93
